SOLARIS
NATIONAL SYNCHROTRON
RADIATION CENTRE

Status of the SOLARIS RF system

21st ESLS RF Meeting

08.11.2018

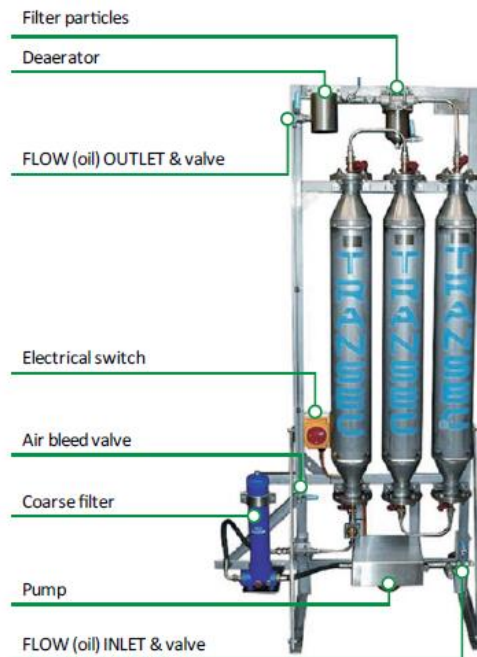
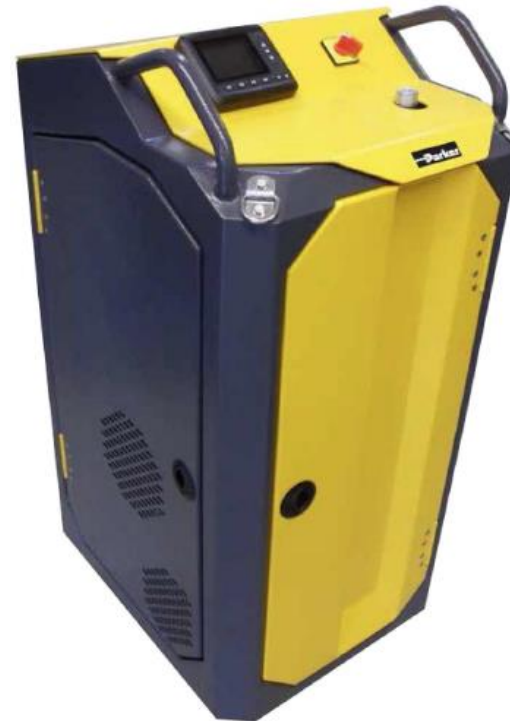
Periodic inspections of the water content in insulative oil required.

- Previous filtration operations proved succesful, although there was still some space for improvements.
- Some amounts of oil were lost during transferring between various containers as filtering devices are suited for lager, industrial size transformers.
- New device of much smaller size has been found, it can do the filtering without shutting down of modulators.
- Some plumbing modifications needed to adapt modulator's cooling system to the new device.

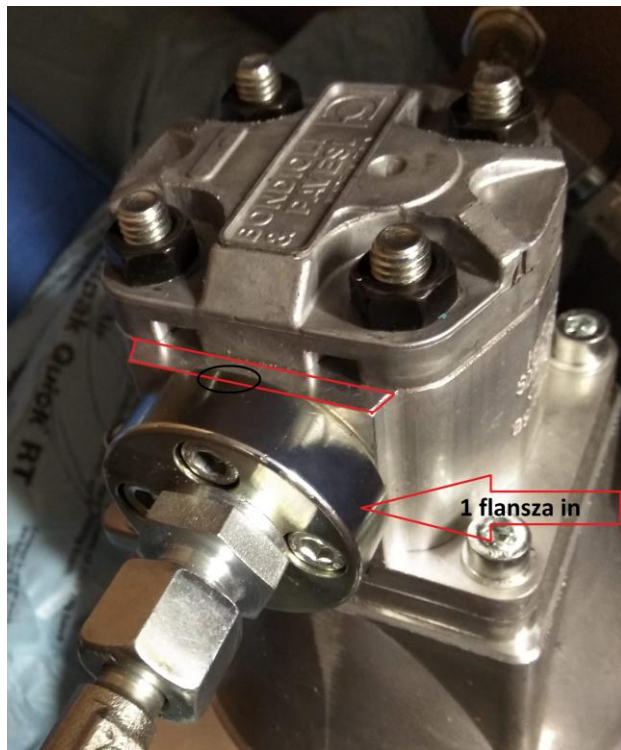
Oil pumps leak a small amount of oil

- Spare o-rings and gaskets ordered. Spare pump was disassembled and inspected for any weak points. Replacement of parts scheduled next shutdown

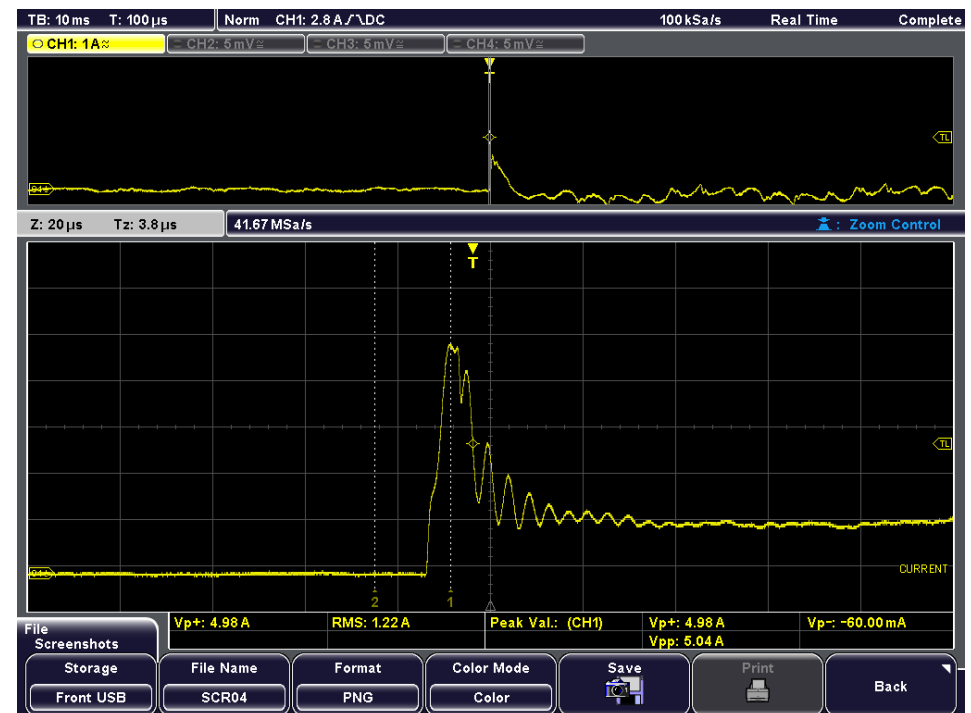
Increased leakage current in some HVPS in modulators.

- Might be a sign of HVPS wearing down, issue requires further investigation

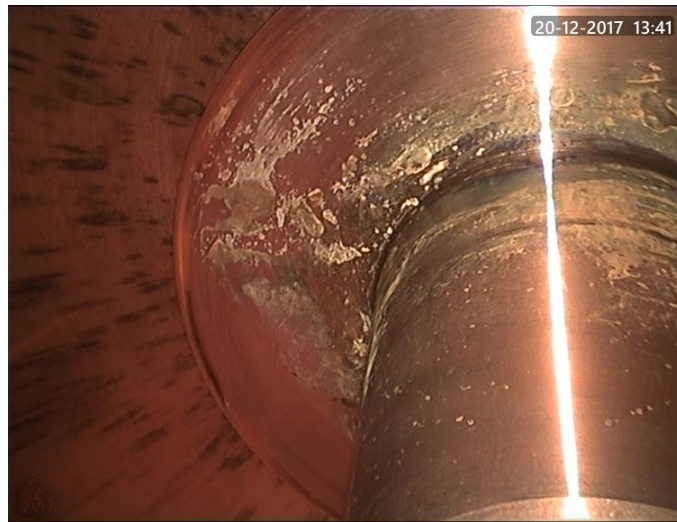
100MHz CAV2, mushroom

- Since machine installation the cavities were not inspected internally.
- During shutdown this opportunity was used to carry out an endoscopy.
- Results were slightly surprising.
- Most of cavities are clean, although some surfaces have clearly visible fingertip marks, and other impurities

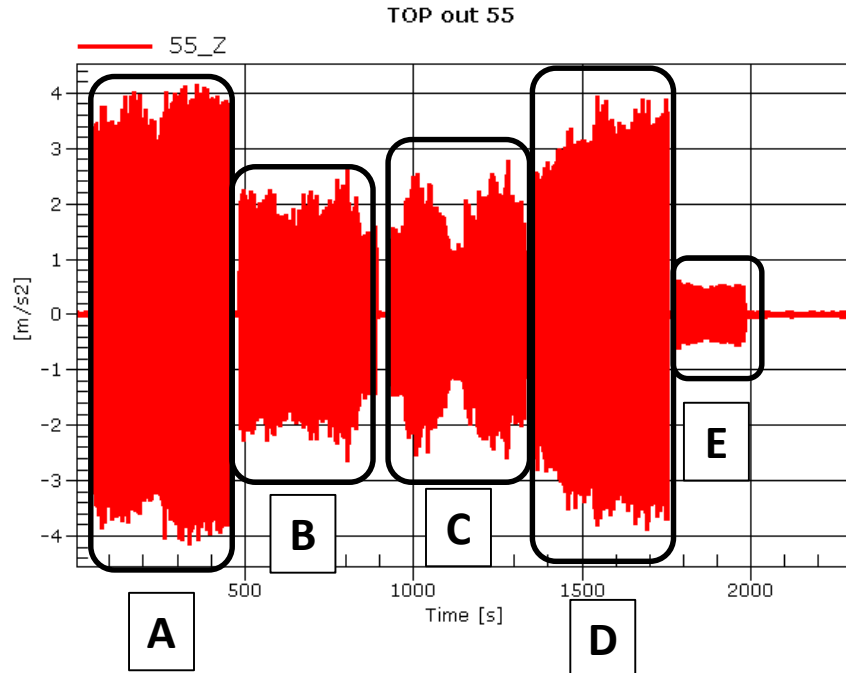
A	Tuning the cavity up (freq up)
B	Returning to resonant frequency
C	Tuning the cavity down (freq down)
D	Returning to resonant frequency
E	Influence of the second cavity

- Mechanical vibrations were measured to see the impact of stepper motors while tuning the cavities
- Measured acceleration values are rather high
- Optimisation of temperature stabilisation algorithms for SHGs could help minimise the need to tune the cavities mechanically
- No data on the effect of vibrations on beam stability – STUDY REQUIRED

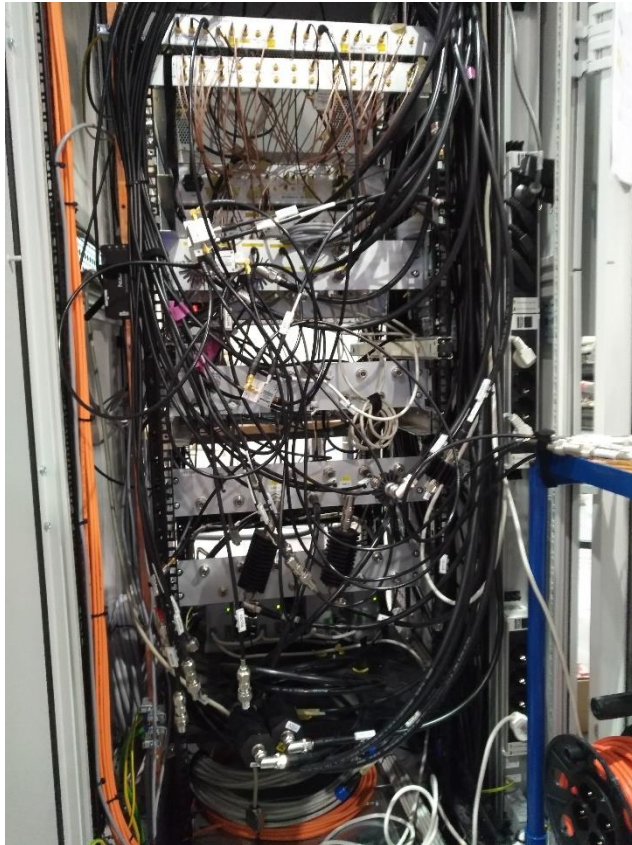
Before

- Many loose cables and attenuators
- Slightly chaotic design
- Rearrangement of cables was performed along with update of documentation
- New patch-panels added
- Much easier maintenance and measurements now

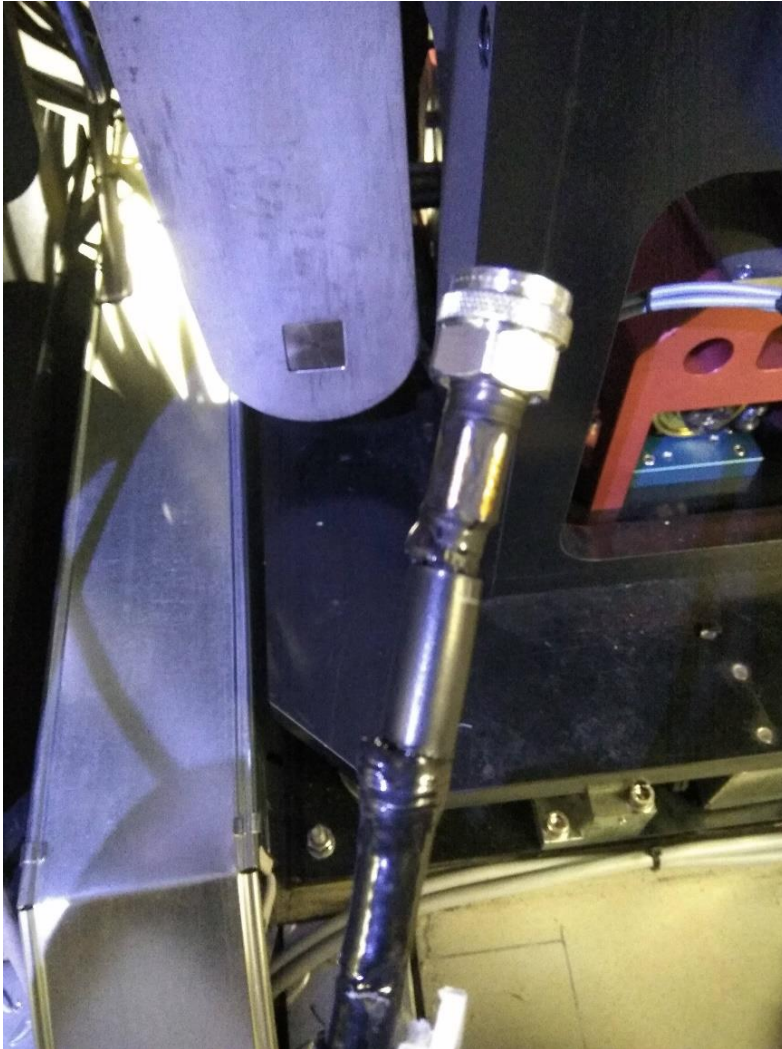
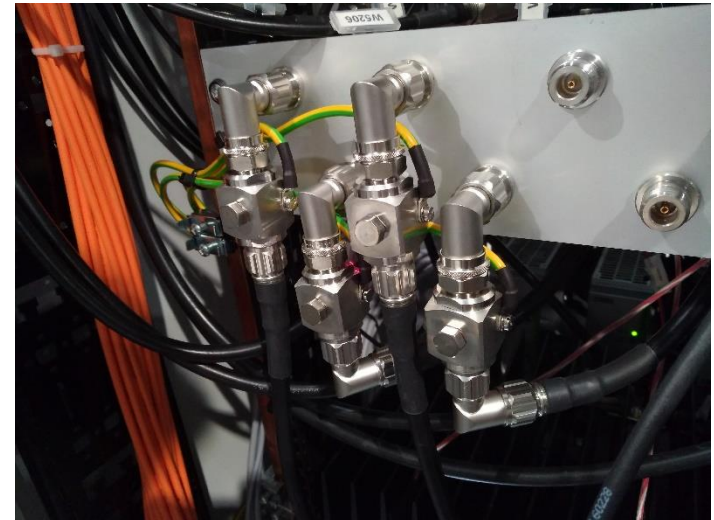
- Lots of HOM modes generated in the cavity
- No grids on pick-up ports – strong coupling
- Dominating frequencies around 1,5 and 1,9 GHz
- Frequent overheating of attenuators and loads
- Gas discharge tubes installed, to contain the problem
- Cable insulation melted, GDTs overheating, damaged RF N-type connector socket
- Bottom pickups do not cause any problems

Should we remove upper pick-ups in landau cavities?

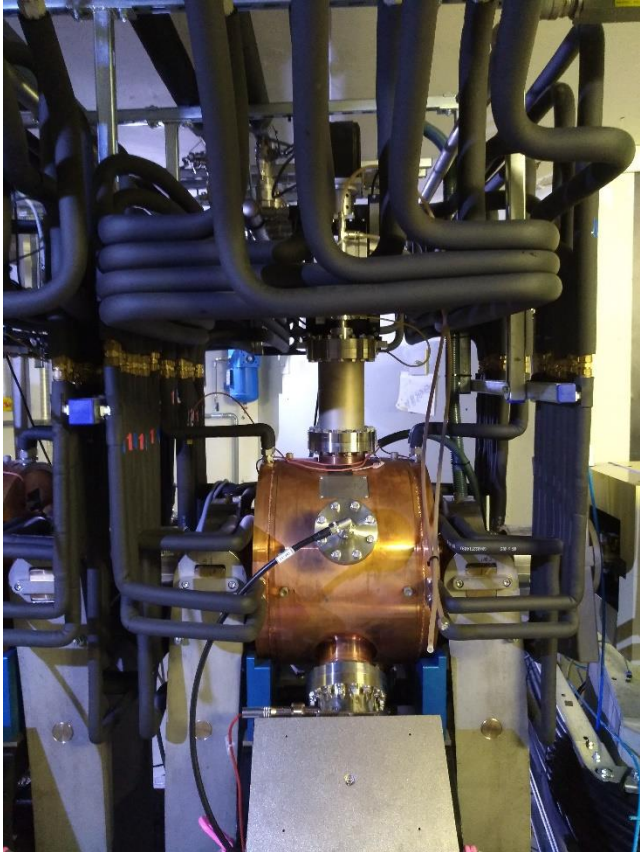
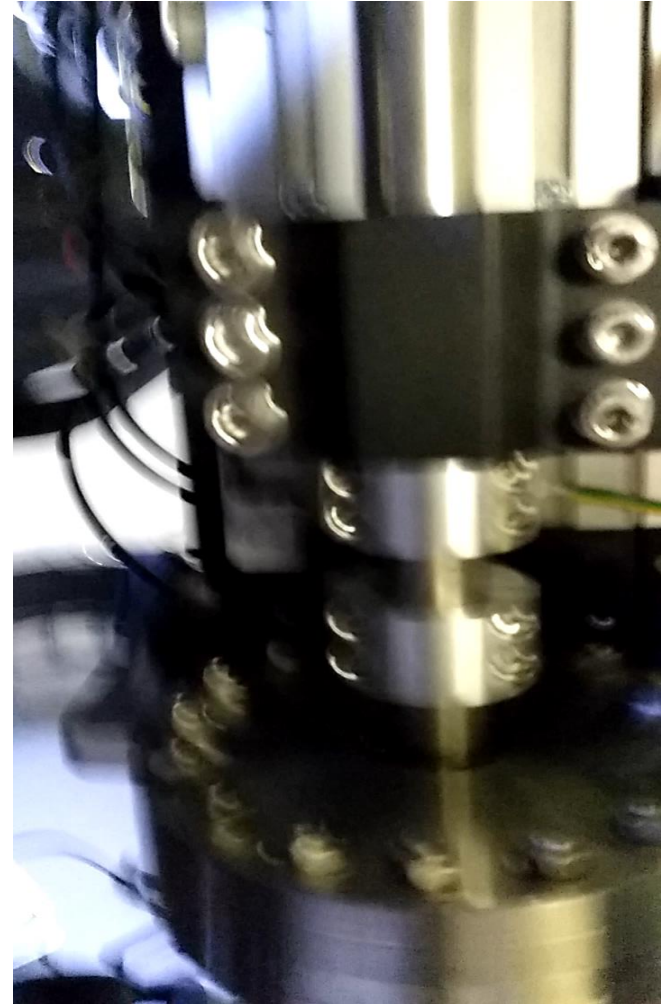
Landau plunger mechanism produces metallic sounds during movement

- Sounds are generated by moving bellow
- The bellow is probably too large
- Issue was investigated but no damage to plunger mechanism was discovered
