SOLARIS
NATIONAL SYNCHROTRON
RADIATION CENTRE

Status of SOLARIS

Paweł Borowiec
On behalf of Solaris Team

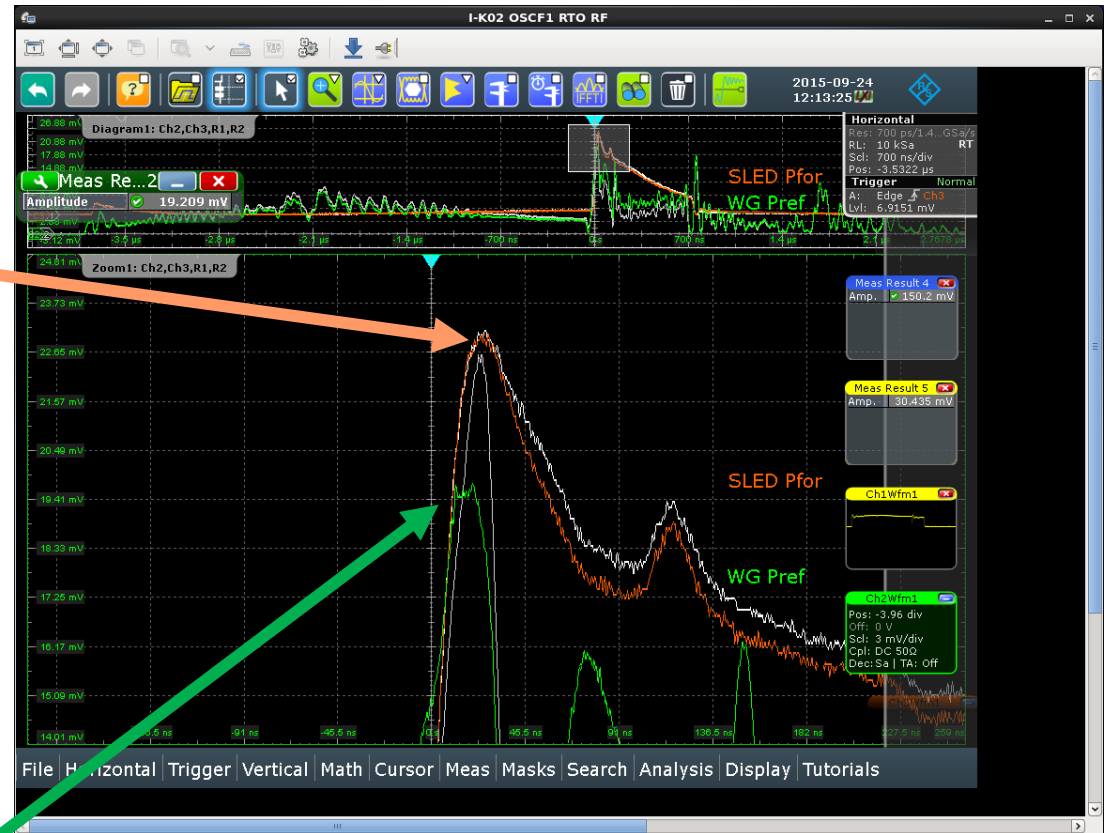
Shortening of RF pulse based on Max IV experience:

- Filling time of SLED from 3,75 μs to 3,3 μs
- Filling time of accelerating structure from 0,75 μs to 0,7 μs

No significant beam energy loss

lower reflected RF power,
less stress for klystrons

White traces show values at previous settings

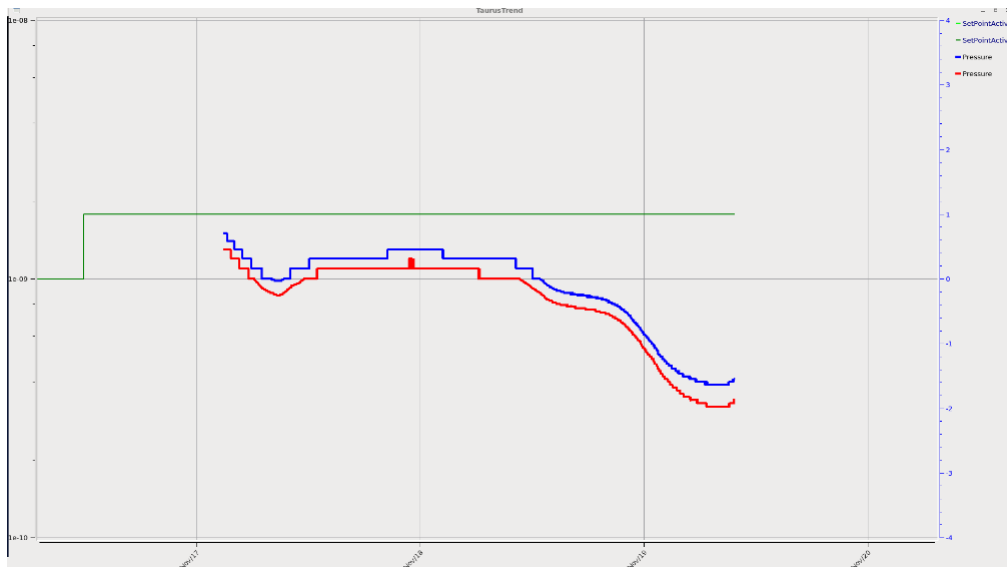
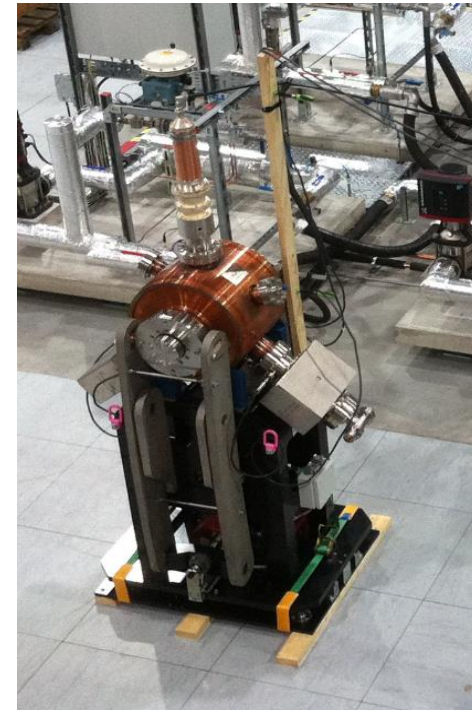
11.2015 Conditioning at 50W only because no test-stand available @ Solaris

- Power coupler borrowed from Max IV
- 50W @ 300MHz RF power, monitoring of Pfor and Pref
- Without cooling, without tuning of cavity
- Manual reflected RF power optimisation (frequency change of signal generator)
- Vacuum interlock,
- No radiation has been observed, no shielding required

Tuning range set from 299,4MHz to 300,4MHz

Some troubles with tuning mechanism:

- **New alignment of worm gear**
- **Greasing**
- **Sensitive adjustment of limit switches**

Second pick-up installed for transmission measurement.

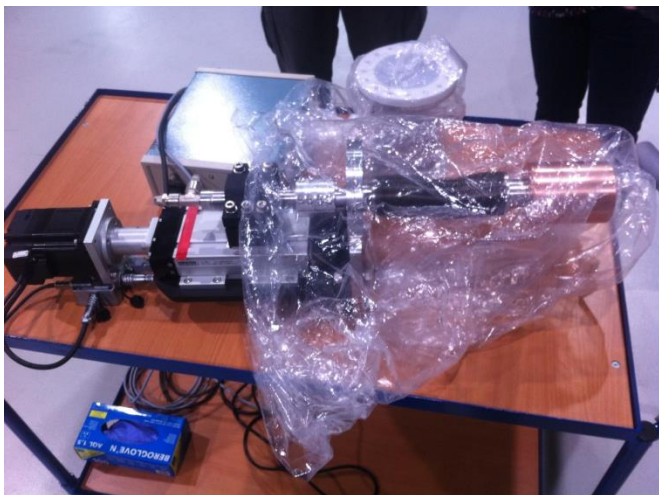
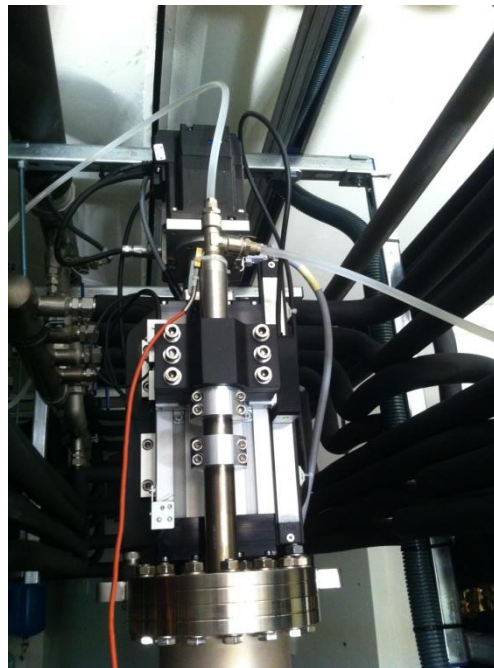
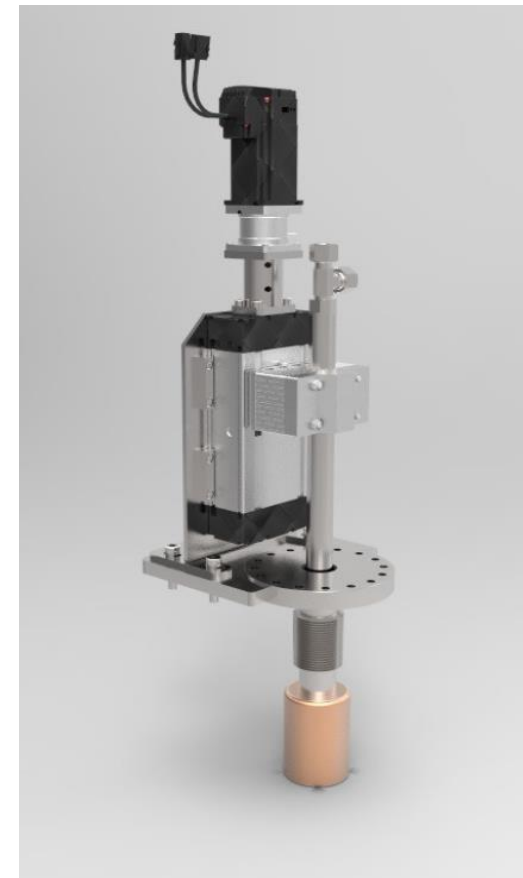
According to simulation* and Max III ring operation the possibility of additional detuning of Landau is necessary during injection and ramping.

- Detuning up to 600kHz in 4 minutes
- Possibility to shift HOM (ev. no needs of extra HOM dampers)
- Installed on CF100 top port of cavity
- Range of movement 80mm
- Step size 0,1mm, encoder included
- Water cooled copper part
- PLC controlled, integrated in TANGO

*Designed by MeasLine, Poland,
based on Max IV concept*

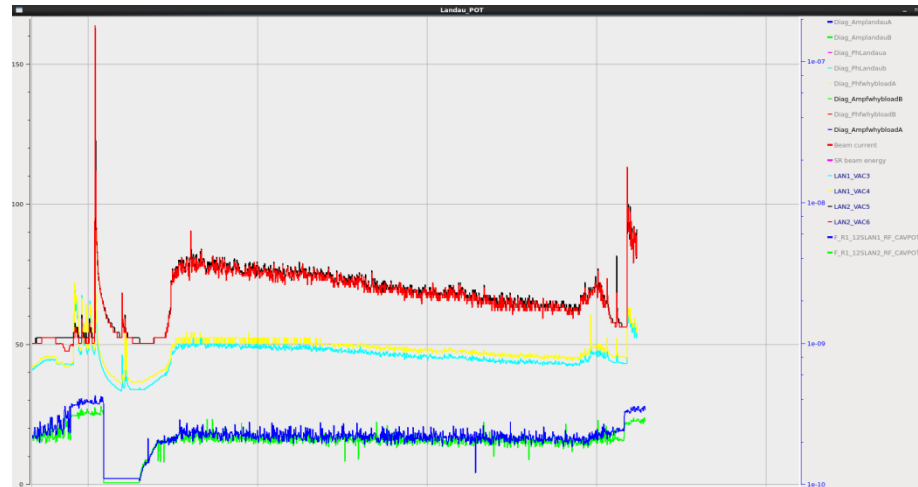
At the beginning not possible to move plunger even by 0,1mm at few mA of beam current @ 1,5GeV, immediately pressure increase and beam dump. Very slow progress till summer shutdown.

Landau cavities with plungers have been installed together at the same time in storage ring. Since Landau cavities have not been conditioned with high RF power, it is not clear what is a source of outgassing.

New conditioning strategy: ramping is paused when pressure is close to 1e-8mbar.

Recent status: full range movement of plunger with ramped 130mA of beam.

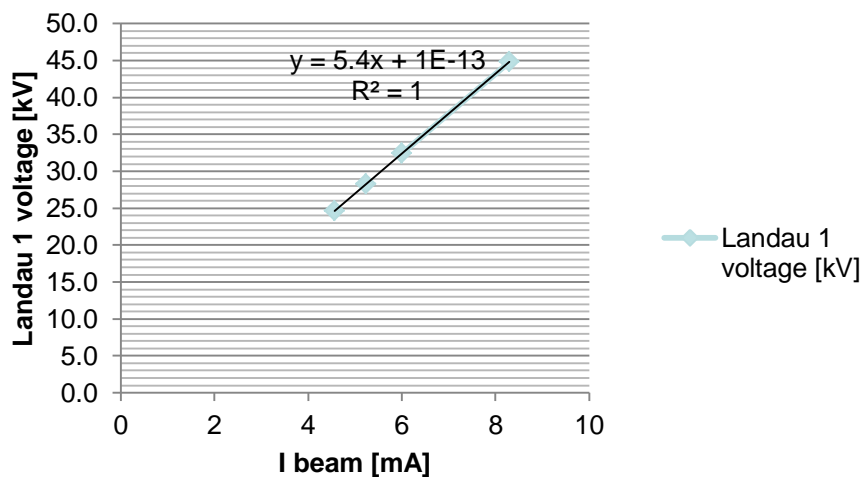
Landau 1 voltage vs. beam current

Landau cavity tuned to 3rd harmonic, plunger retracted.
Low current in storage ring.

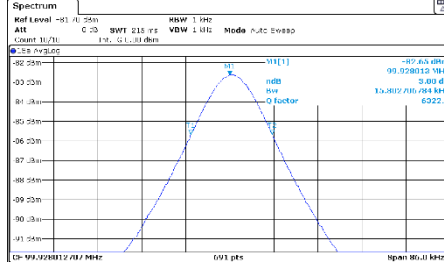
Fundamental frequency 99,92MHz

Transmission measurements with spectrum analyzer equipped with tracking generator.
Frequency range from 99MHz (299MHz for Landau) to 1,5GHz
Measured at 30°C, 40°C, 50°C

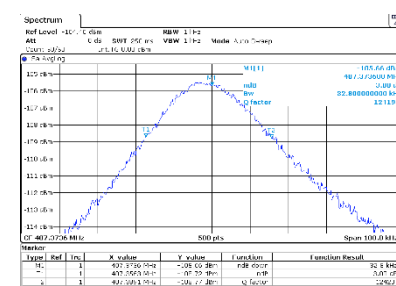
First HOM 407,37MHz

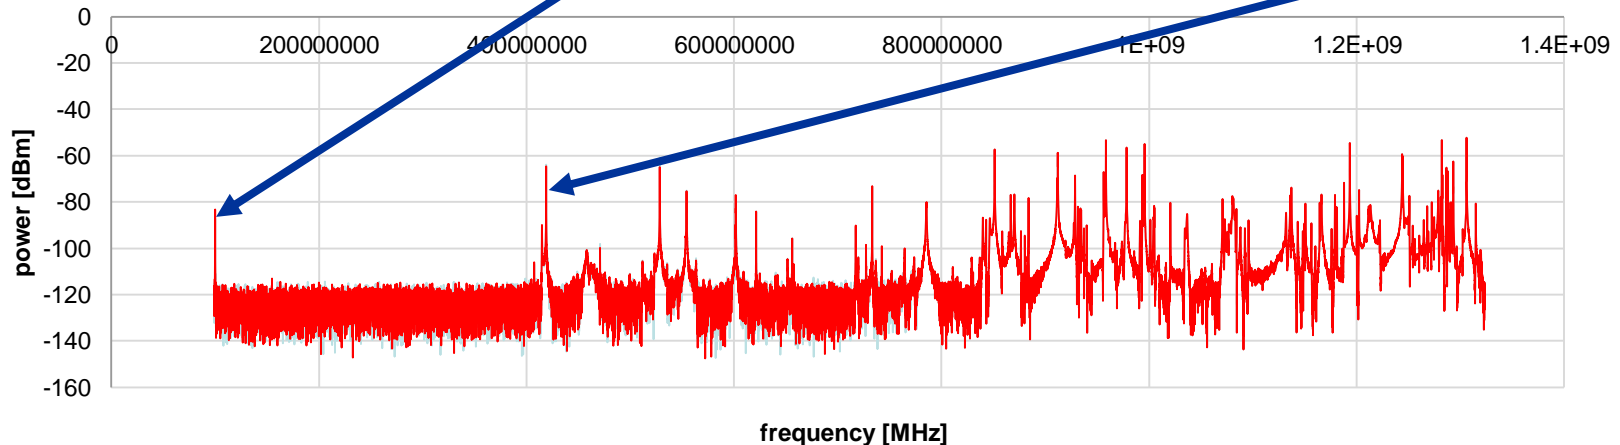
HOM in main cavity

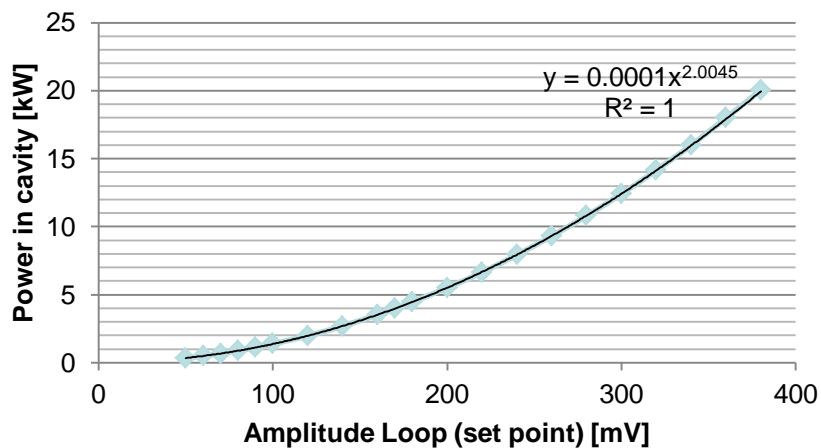
RF power in CAV1 [kW]

Characterization of RF power in system versus LLRF settings. Performed up to 25kW.
Formulas will be implemented in TANGO control system

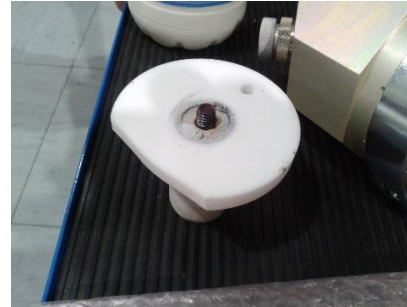
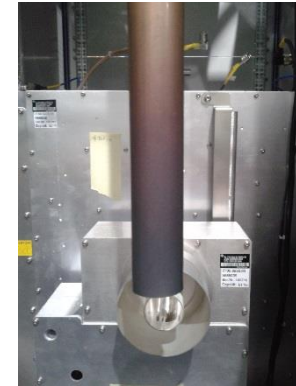
- Overheating of 3 1/8" elbow, wrong inner spacer assembly

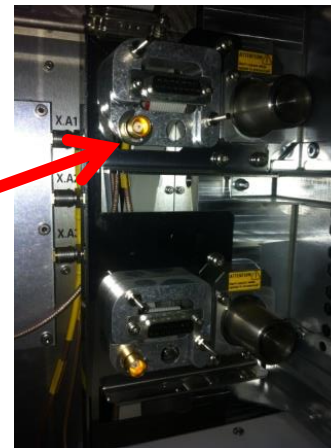
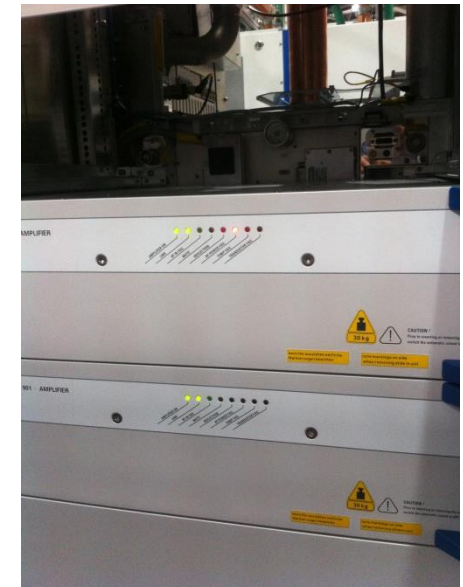
RF input connector mechanical problem.

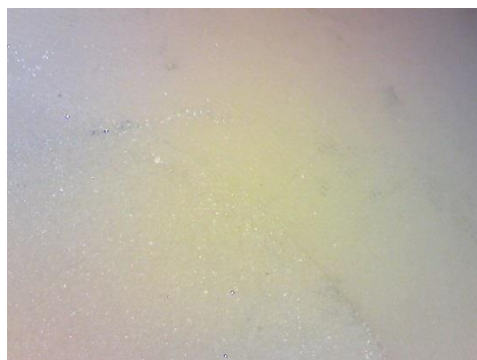
Ceramic – vacuum side, 30x

Metal inclusions

- Stacked tuner mechanism, no grease in tapered roller bearings. Exchanged for new ones in both cavities.
- Leakage up to $1.0e-7$ mbar*l/s at ceramic of pick-up (already 4 pieces), even after one discharge in the cavity. They will be replaced for pick-ups loop without ceramic (Max IV concept), manufacturing by Research Instruments under warranty.

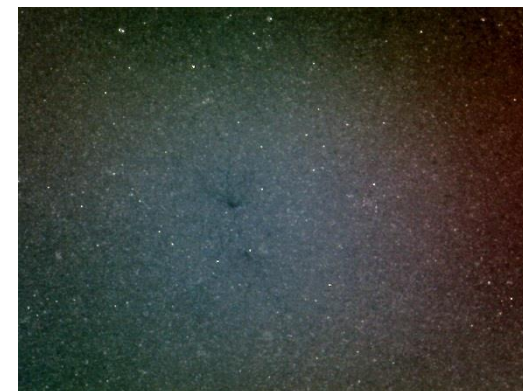
Crack
