SOLARIS
NATIONAL SYNCHROTRON
RADIATION CENTRE

Status of the SOLARIS RF system

21st ESLS RF Meeting

08.11.2018

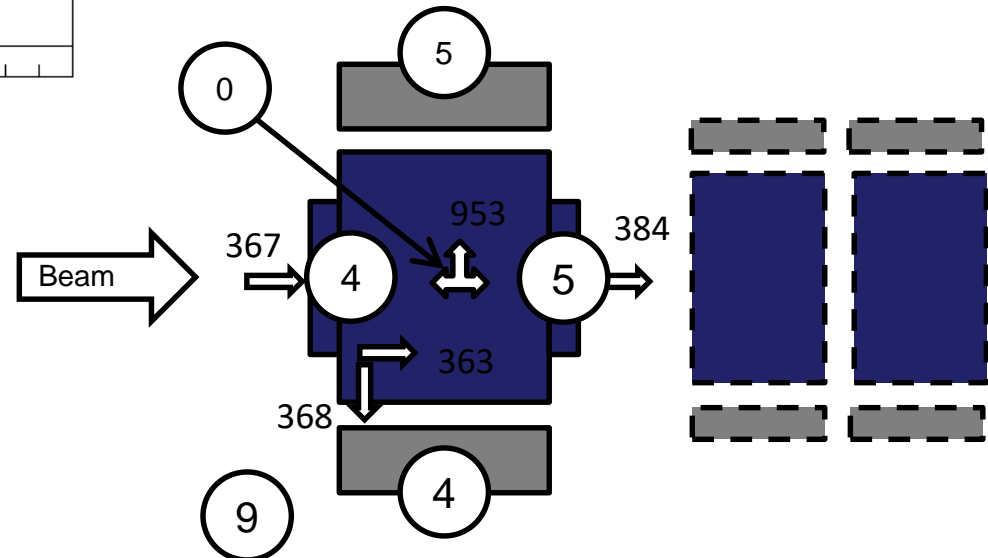
Placement of sensors, top view

Vibration measurements

- Mechanical vibrations were measured to see the impact of stepper motors while tuning the cavities
- Measured acceleration values are rather high
- Optimisation of temperature stabilisation algorithms for SHGs could help minimise the need to tune the cavities mechanically
- No data on the effect of vibrations on beam stability – STUDY REQUIRED
